CONSTRUCTION GENERAL PERMIT SITE INSPECTION REPORT - LEVEL 1 (FOCUSED)

Project Name:	Louisa Solar (Virginia Electric & Power Co).	Permit Number:	VAR101424
Project Address:	495 Chalklevel Rd. Louisa, Virginia	County/City:	Louisa
Project Operator:	See comments section.	Operator Telephone:	See comments section
Project Contact:	Robert B. Smith, Project Manager	Contact Telephone:	804-273-3725
Contact E-Mail:	Rob.smith@dom.com	Qualified Personnel (QP):	James Dorton/Regina Chavis
Inspectors:	Tadric Page and Trisha Beasley	Weather (Wet/Dry/Rain):	Overcast w/light rain, ~70 F
Disturbed Acreage:	~174 acres	Inspection Date & Time:	October 6, 2016 @9:00 a.m.
Linear Project:	<input type="checkbox"/> Yes <input checked="" type="checkbox"/> No	Annual Stands. & Specs:	<input type="checkbox"/> Yes <input checked="" type="checkbox"/> No
		VSMP Authority:	<input type="checkbox"/> Locality <input checked="" type="checkbox"/> DEQ
Stage of Construction:			
<input checked="" type="checkbox"/> Initial Clearing & Grading <input checked="" type="checkbox"/> Rough Grading <input checked="" type="checkbox"/> Building Construction <input checked="" type="checkbox"/> Final Grading

CONSTRUCTION GENERAL PERMIT

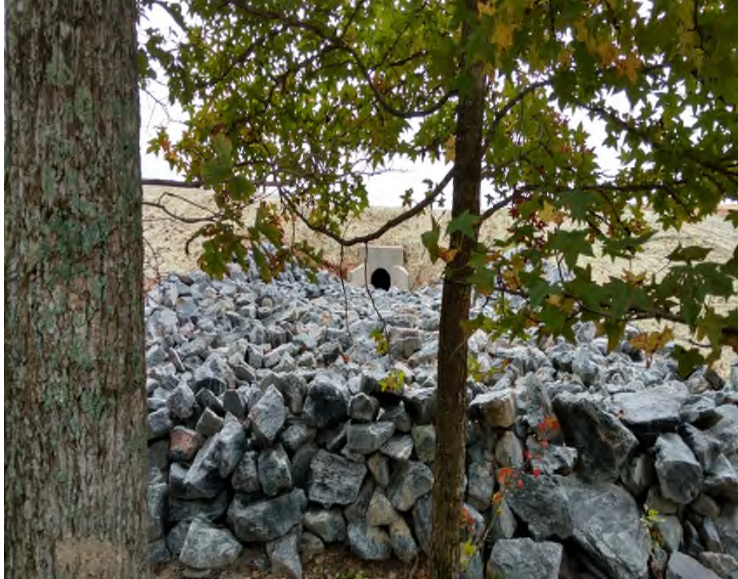
Fig. 1 showing basin discharge above stream-crossing #1

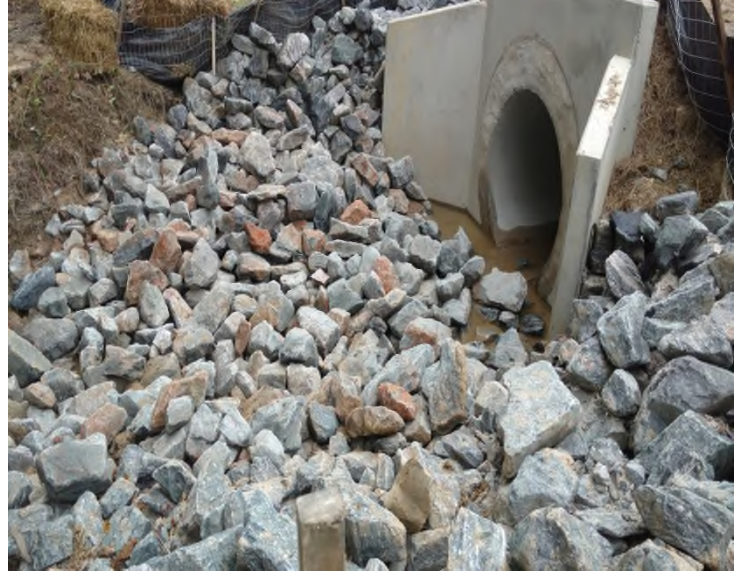
Fig. 2 showing outlet protection at stream-crossing #1.
